Master's Thesis

The structural intervention of
St. Torcato Church:
documentation and analysis
of the strengthening works

University of Minho

Year: 2014

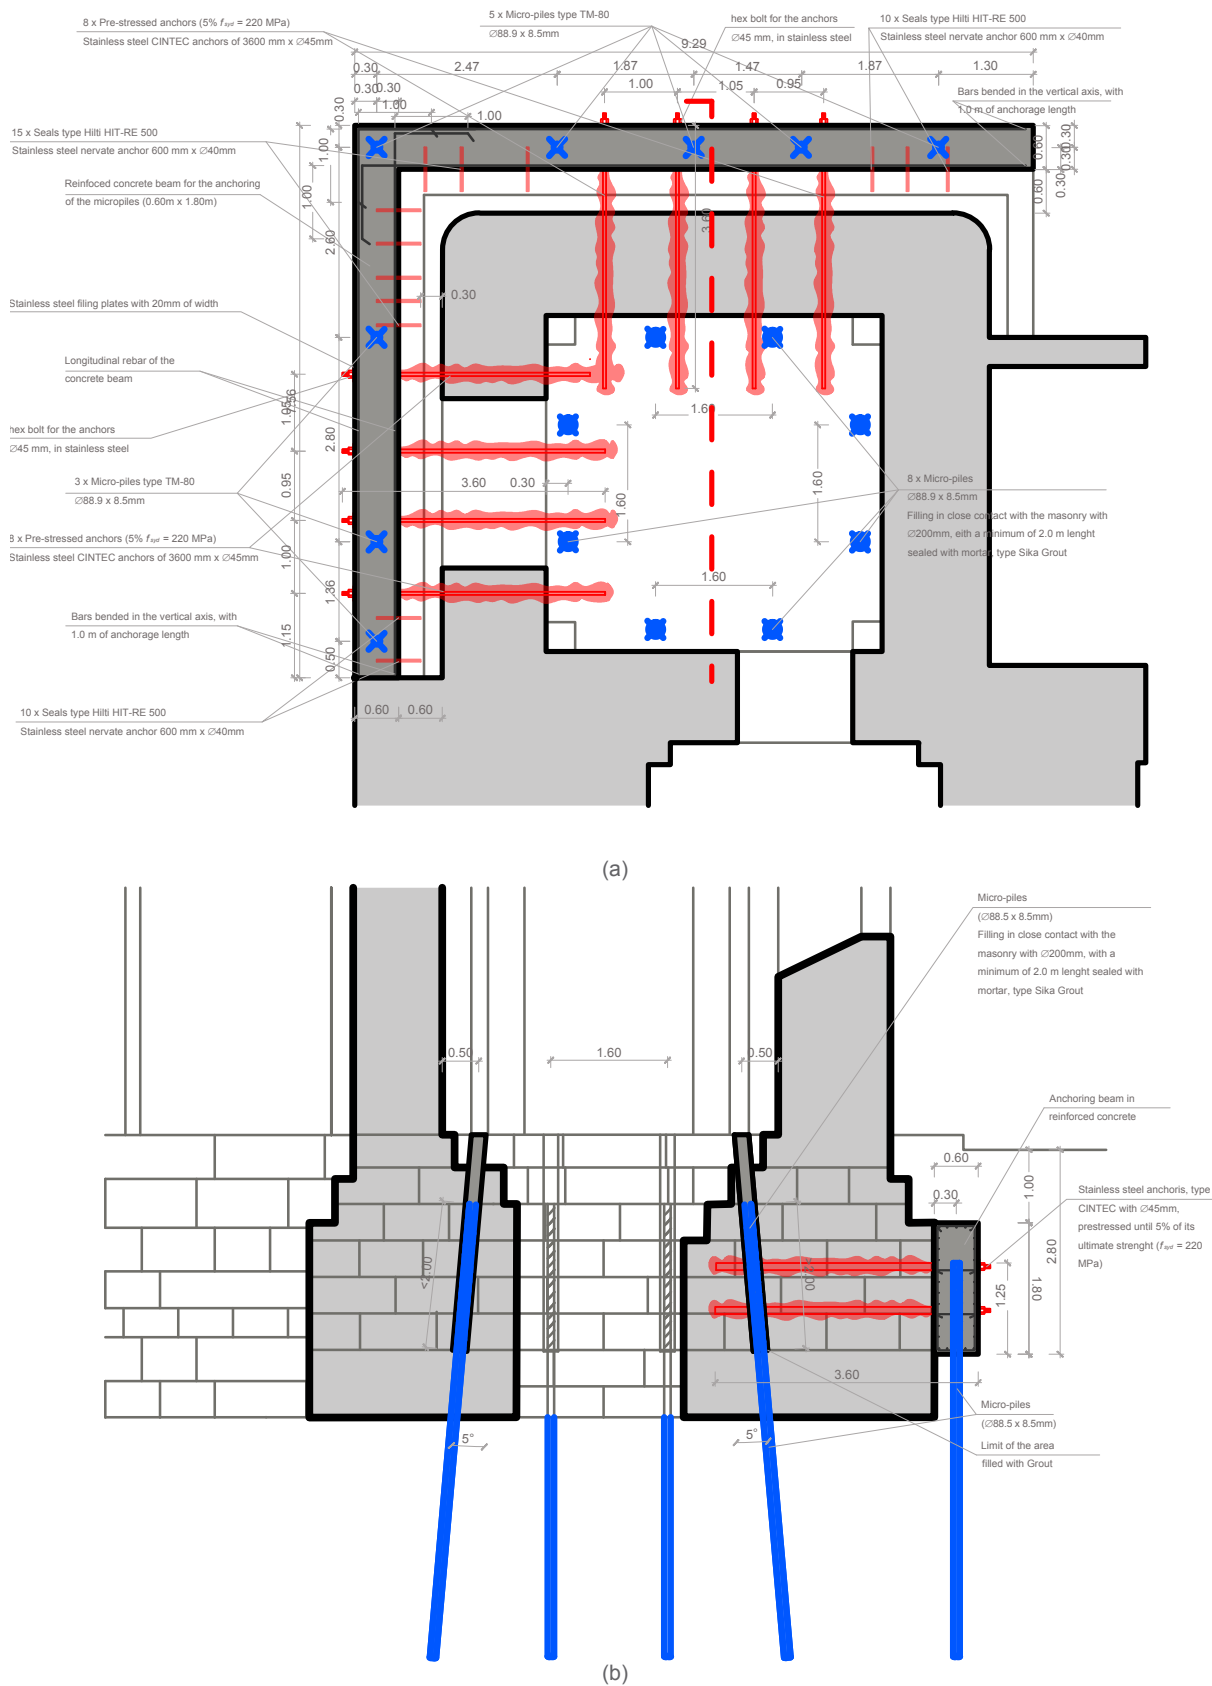
Figure 4.2: The system of foundation strengthening designed: (a) plant (b) section

A system of micro-piles, type M-80, will be used to transfer part of the towers weight directly to the resistant bedrock. A set of eight vertical piles will be placed in the lateral and in the façade sides of both towers. In addition, other six piles will be positioned along the perimeter of the interior area of each tower to collaborate with the external ones (Figure 4.2).

The length of the micro-piles will be as sufficient as to reach the bedrock layer, sited around eight meters below the street level. The weight transferred by such ancillary structures will be around 20% of the towers dead load, estimated considering a simplified geometry of the towers and a mean specific weight of the granite. Each pile is a hollow structure of steel of 8,5 cm of diameter and 8,5 mm of thickness, with a bear capacity of 590 kN in compression. The piles will be filled with high resistance concrete CEM I 45,2 R after their positioning. On the exterior side, a concrete beam with L shape will be added and anchored to the foundations in order to create a bridge through which the loads would be transferred from the towers to the micro-piles. The insertion of micro-piles into a concrete beam is known as “underpinning” method. The attaching of the concrete beam will be provided by eight pairs of active stainless-steel bars (four on the façade and four on the tower side) of 3,6 m length and 45 mm of diameter, placed in proper holes previously drilled and fixed by grouting. Several steel reinforcing bars of 40 mm diameter will be sealed to the structure to improve the anchoring level of the beam (figure 4.2).

It was not possible to develop the same system in the interior of the towers because of the shape of its foundations. For this reasons, the micro-piles sited in the interior will be installed directly on the masonry basement and will work for friction with it. This ancillary structure will be drilled pointing to the exterior of the building, so that different stone elements will be crossed; a minimum of four bond layers will be involved in the anchoring system. It is important to remark that, to avoid rotational instability of the forces, the starting of the micro-piles adherence with the masonry structure will begin in the same level both for internal that for external sides (figure 4.2).

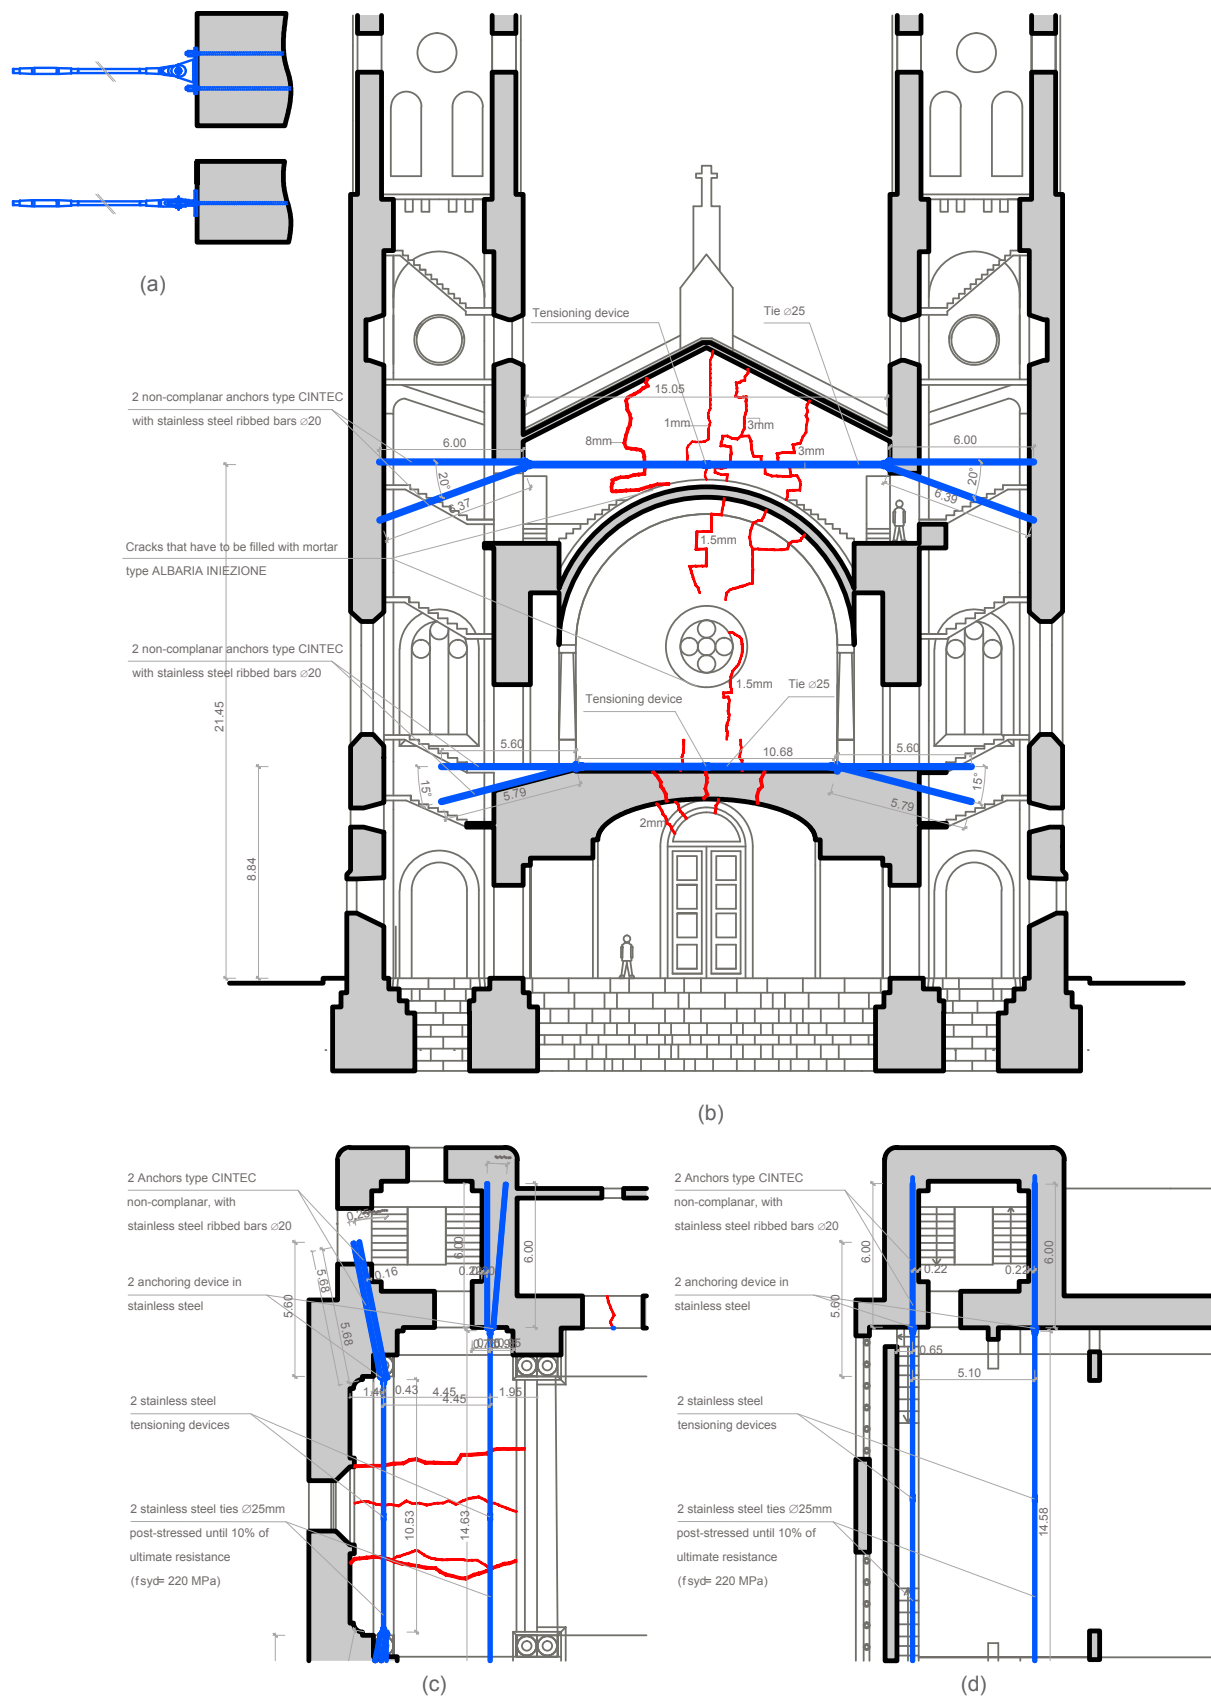
Figure 4.3: The system of anchoring designed by professor Ramos: (a) detail of the connection (b) section (c) plant at the choir level (d) plant at the vault level

The monolithic behavior of the façade will be recovered with the union of the towers with proper steel ties. If the design of this system took into account the development of differential settlement of the structure, it would be necessary to increase excessively the intervention impact. Thus, Considering that the root causes of the soil settlement will be eliminated with the micro-piles intervention, this system will provide tensile resistance against unlikely further openings of the cracks. Four post-stressed ties will be placed in a suitable position to achieve a good constrain of the towers and in the same hide the intervention from the sight of the building users. Two couples of ties will be installed at the choir level, just on top of the floor. Other two couples of ties will be placed in the attic on top of the vault extrados (Figure 4.3).

The ties will be placed in the most symmetrical position as possible with respect to the towers axes, in order to avoid the transmission of torsional effects in case of relative tilting of the towers. For the evaluation of the force that will be applied on the ties it was considered the investigation performed by the SAHC student in 2013. By means of an FE analysis, they considered that the maximal tension that will arise due to the presence of ties is 68 kN (Merluzzi et al., 2008). It was chosen a diameter of 25 mm and a pre-stressed level equal to 10% of the yielding force (220 MPa) to face the relative force. The ties are secured to steel plates with a hinge that permits the relative rotation of the structural parts. The plates are fixed to the structure by means of two ties anchored inside the tower walls for a length of six meters. The anchoring system of the clamps is achieved by the CINTEC reinforcing method: a socket is inserted inside a hole drilled with diamond-cut technology, then a ribbed rod is

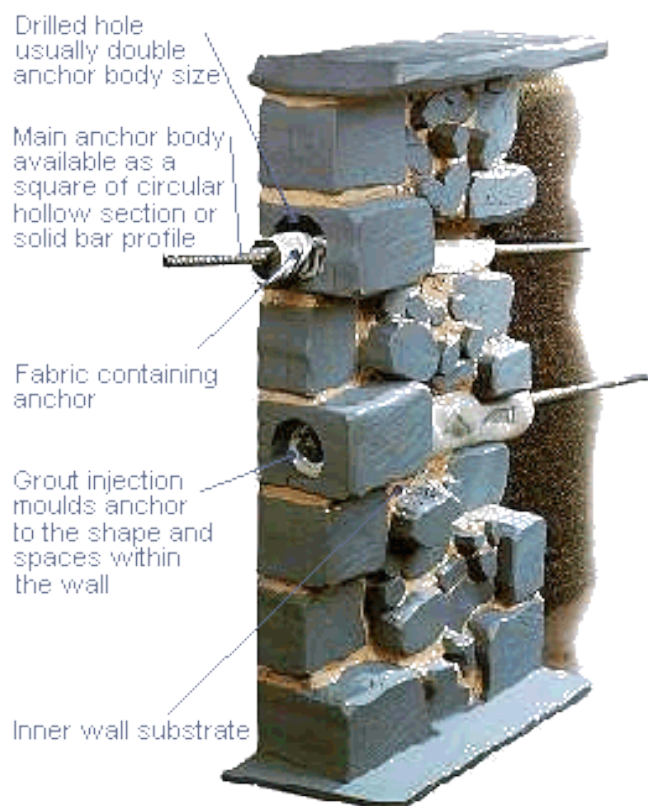
Figure 4.4: The system of anchoring developed by CINTEC, chosen for the intervention on the church (www.cintec.com)

inserted inside the sleeve and cement is grouted with high pressure, in this way the socket will expand guaranteeing a good anchoring with the surface of the hole (Figure 4.4). The two holes will be cut in diagonal way with a different inclination, in order to cross more bonds as possible and assure a perfect anchoring. The executive procedure will be the following:

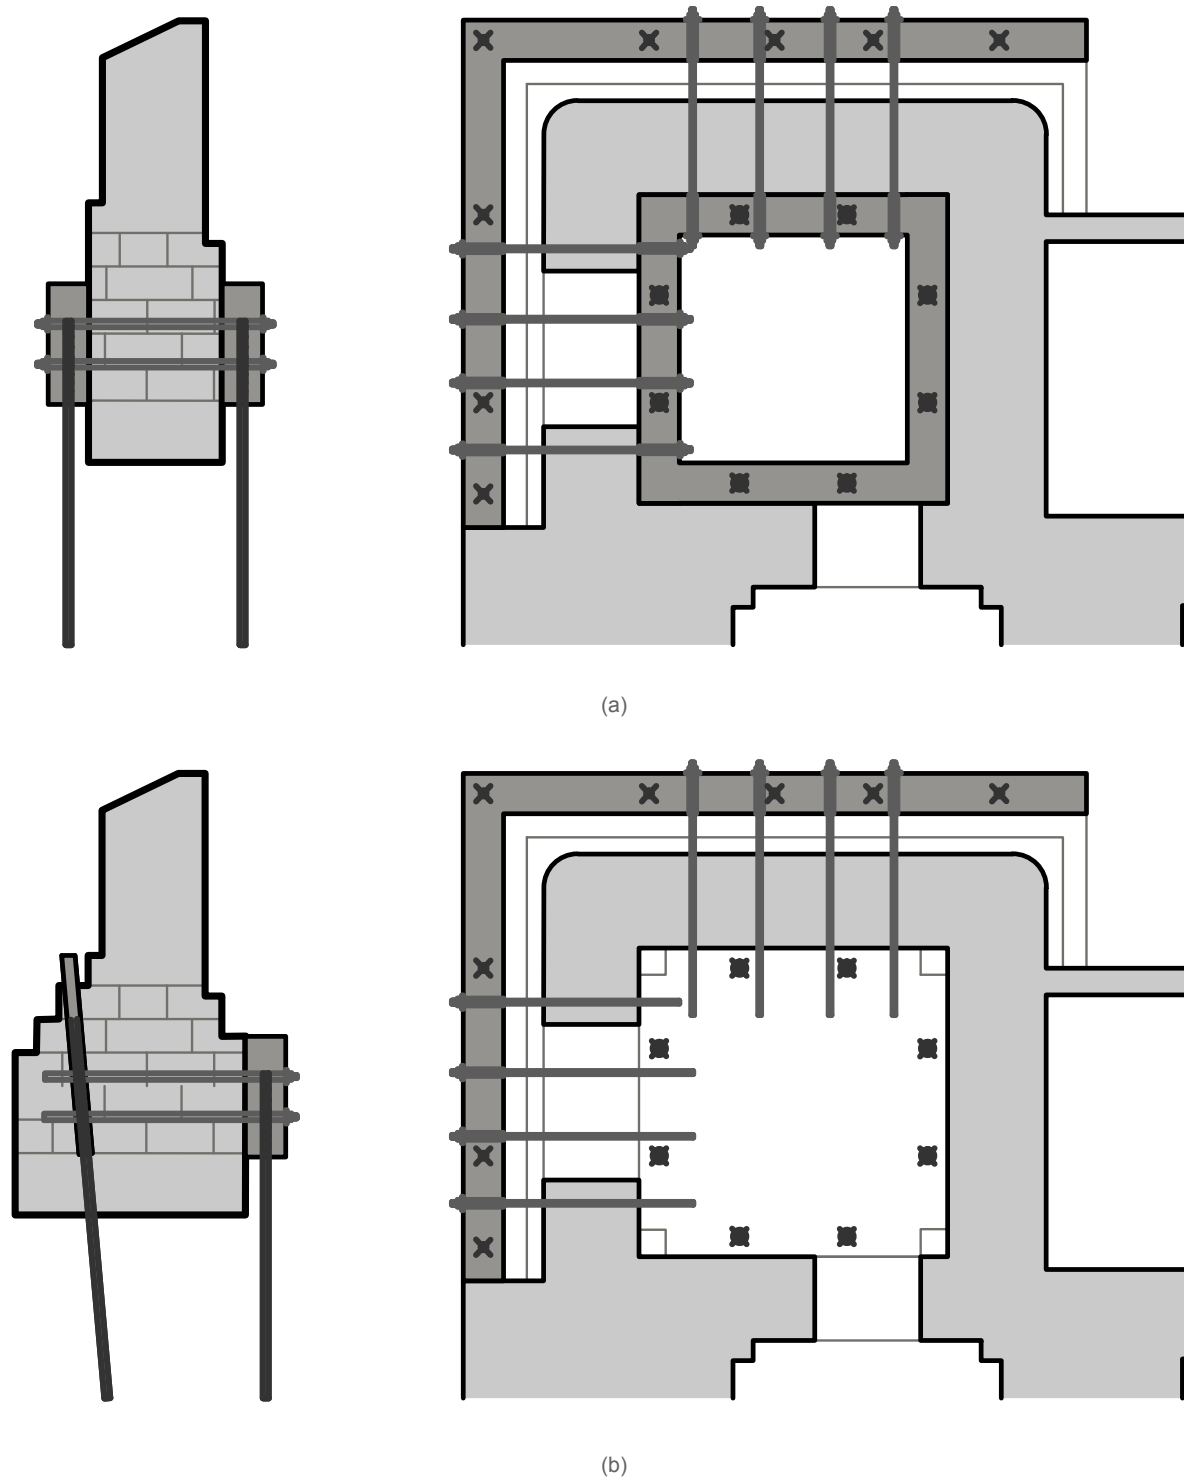
Figure 4.5: Changes of the design during the time: (a) first design, two concrete beam were placed in the tower and anchored with shear connector (b) last project, the internal beam disappear and the intervention takes into account the real shape of the foundation

The strengthening works previously described represent the last step of a long process. The first design, in fact, was slightly different. In that case the concrete beam was coupled with a ring beam placed inside the tower. Subsequently, the shear connectors were passing through the whole system, assuring a perfect anchoring of the system. This design was based on wrong drawings that were reporting incorrectly the shape of the foundations. The update of the drawing and the subsequent change of the design were necessary after the visual inspection of the foundations (Figure 4.5).

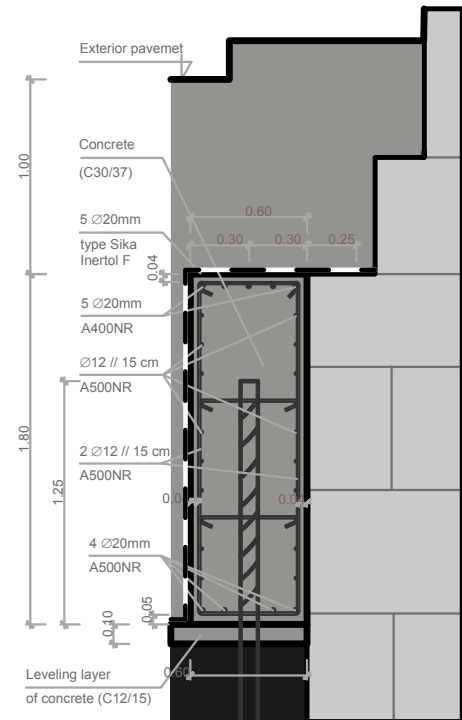
width (Figure 4.8). Such values, however, are attributable to anchoring requirements: the piles precise a minimum of 1 m of anchoring while the shear connectors need a minimum of 30 cm. The average normal stress at the base of the foundation (0,16 MPa) was used to define the force applied on the beam. For simplification, the load transferred by the connectors was considered as a distributed force, and the same stress flow described in the previous paragraph was used (Figure 4.7). The beam was divided in two elements and the stress was transformed in linear distributed force (respectively 250 kN and 290 kN) considering the depth of the relative area of influence (Figure 4.9). Once the diagram of shear and moment were evaluated by means of Ftool, their maximum values were chosen to verify the beam under ultimate limit state for bending and shear (respectively 170 kNm and 730 kN). The heterogeneous distribution of the moments brought, however, to a redesign of the piles that will be discussed in Section 4.6.

Figure 4.8: The beam designed for the intervention of Professor Ramos

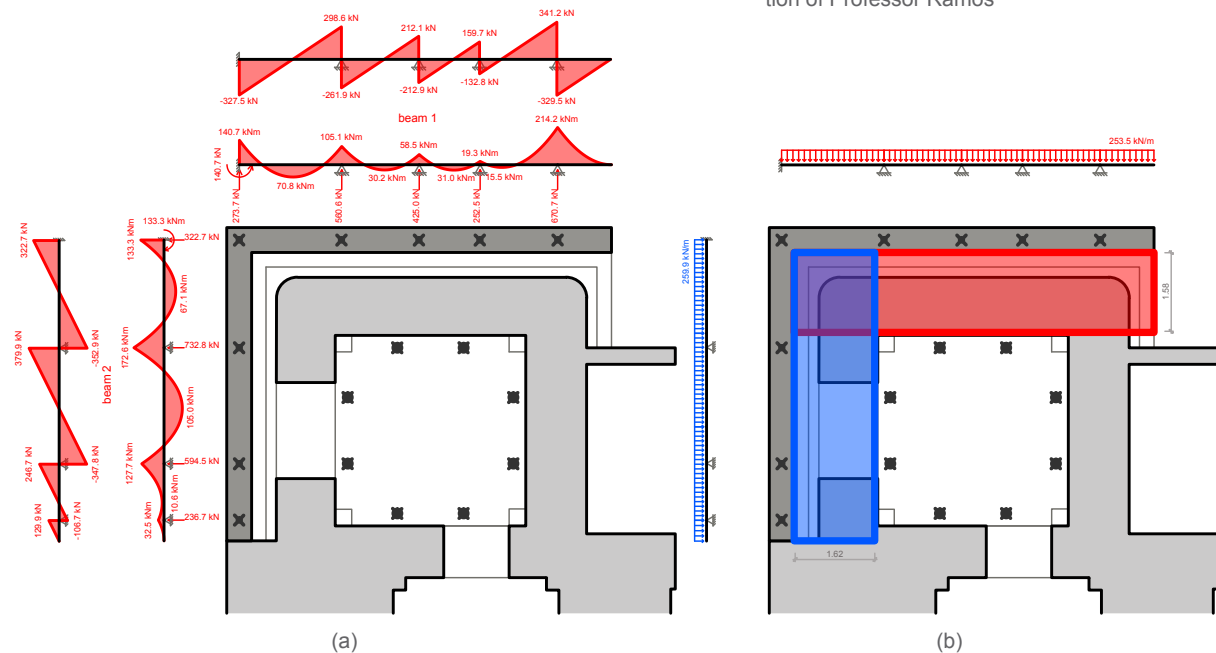
Figure 4.9: Verification of the beam: (a) diagrams of shear and bending moment (b) definition of beam loads

The verification was performed considering the parameters defined by Eurocode 2 (Design of concrete structures), together with the material characteristics assumed in the project (cement CEM I 42,5 R and steel R400NR). The results are completely satisfying as expectable for a beam of such dimensions and with such level of reinforcement. Just the 20% of its capacity would be used under bending design actions. It is important to remark, however, that theoretically the beam should be able to resist in buried condition for centuries: this means that the steel have to be big enough to face possible chemical

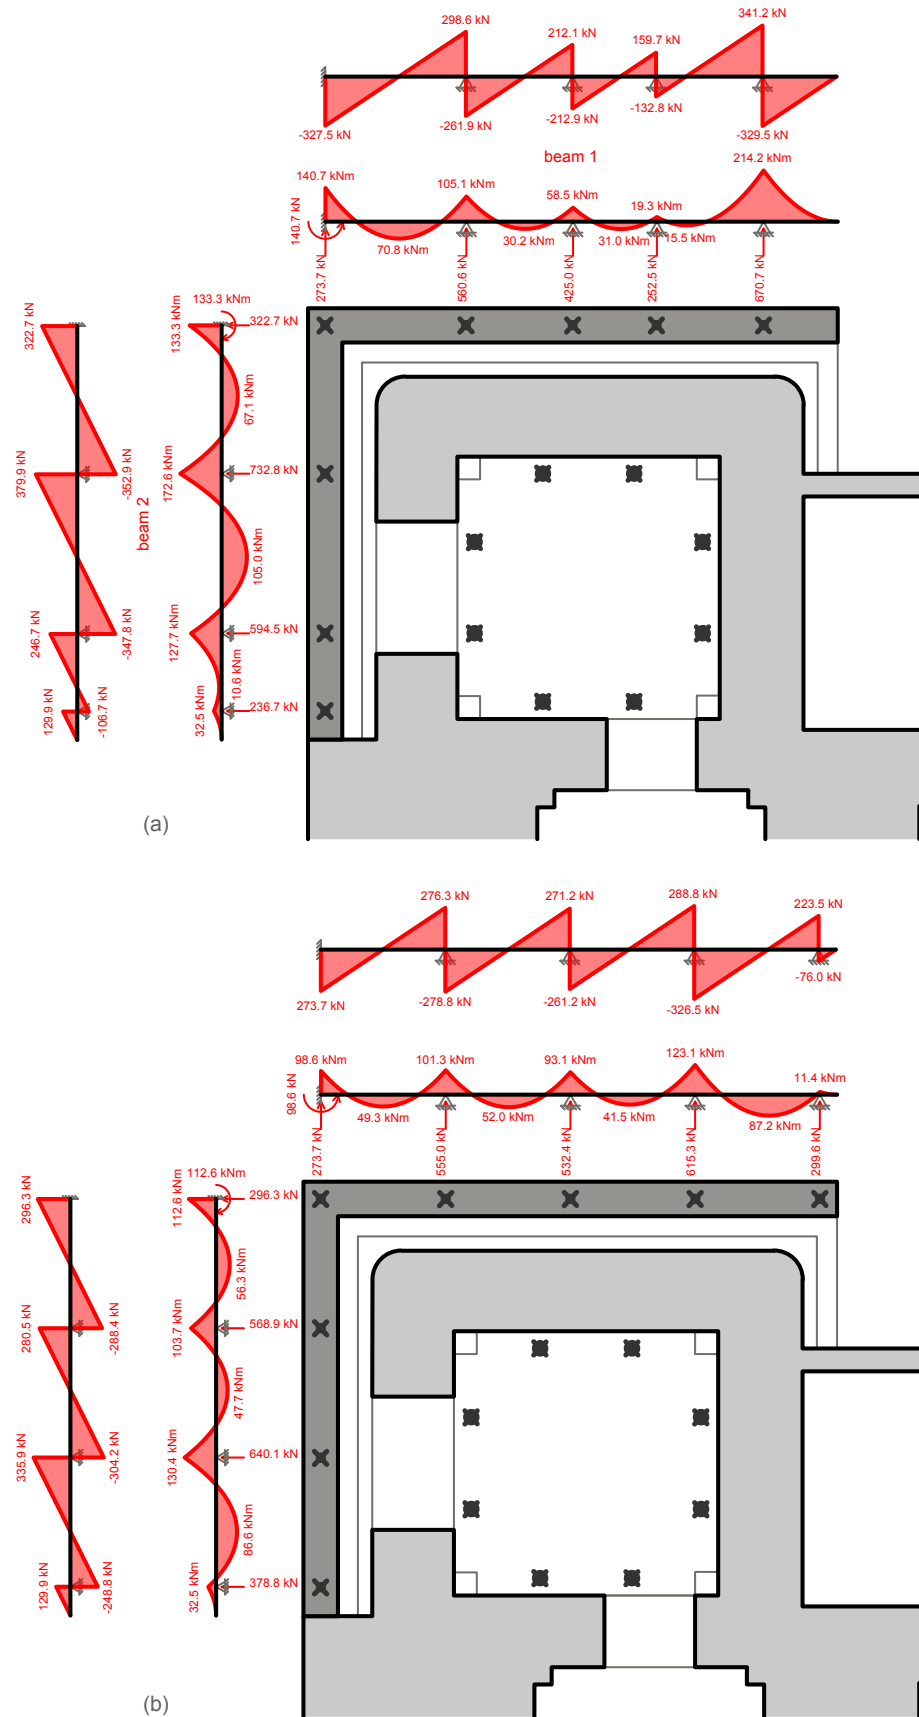
Figure 4.10: Comparison of the updated drawings, with the remarkable reduction of bending and shear solicitations: (a) the design defined by Ramos (b) The personal updating

As mentioned in Paragraph, the bending and shear distribution through the beam was not homogeneous. This is basically due to the variable spacing among the micro-piles. For this reason, it was considered to change the position of the micro-piles in a more rigorous scheme, without affect the position of shear connectors (Figure 4.10). In this way it was possible to rearrange the distribution of the actions in a more appropriate way, reducing bending moment until 40% and shear force until 12% without changing the number of micro-piles (Figure 4.11). The value of maximal shear force analyzed in the beam should not be plausible with the micro-piles resistance, because this limit would be overpassed. It is necessary to take into account, however, that part of the load will be transmitted by the piles to the soil for friction, some of the weight will be transferred directly from the beam to underlying soil and the system of piles will activate a group effect, a beneficial consequence not considered in the previous analysis. For this reason, it is likely that the load will be rearranged by the structure without reach the limit capacity of the micro-piles. The comparison of the other diagrams diagram developed in the analysis are visible in Annex B.

As a result of this last analysis, the previous project was discarded and the updated version was instead chosen for proceed with the executive works.

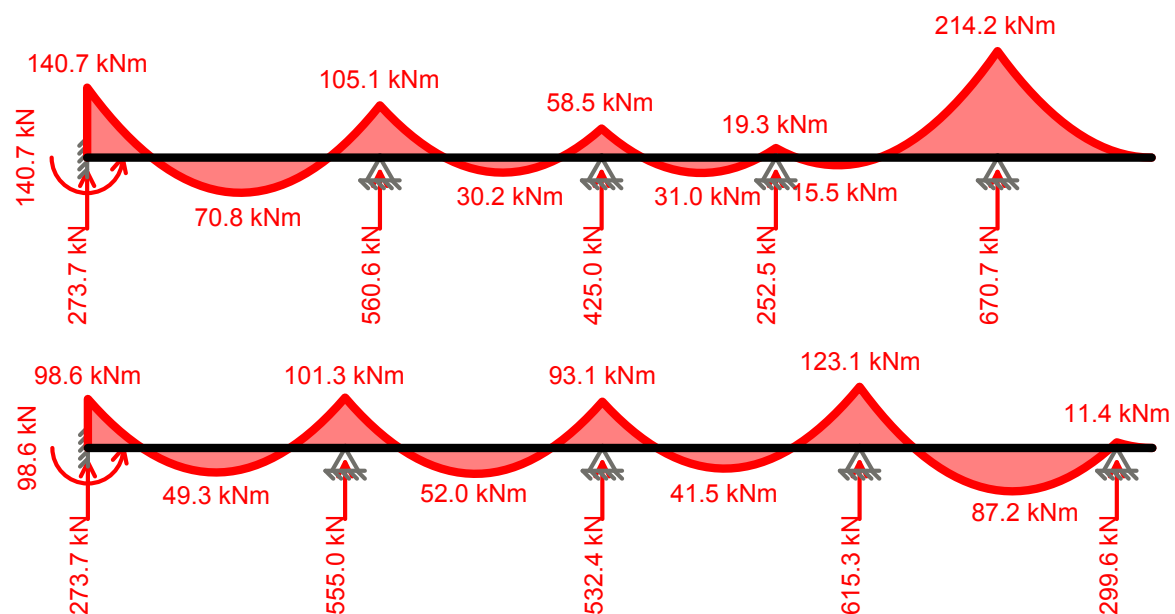
Figure 4.11: Difference in bending moment diagram between Ramos' design (on top) and the personal design updating (in the bottom). The enhancement of the system is visible both in the decrease of the maximal bending than in the rearrangement of the support reactions

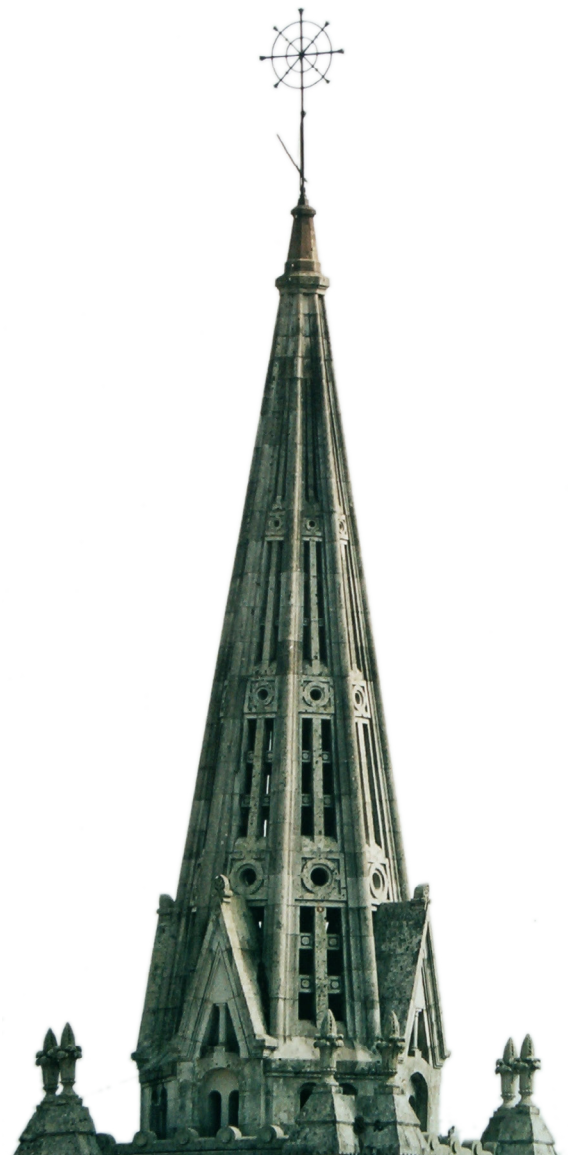
The cross is an iron detail present on top of both towers spire, one of which works as lightning rod for the surrounding area (Figure 5.1). The shape of this roof element is simply defined by two perpendicular bars of rectangular section, with sharp corners. The crossing point of those arms represents the center for a detail superstructure, defined by two concentric circles. Moreover, a minor cross rotated 45° with respect to the main one adorns the element. A decorative element is fixed to the terminal part of each brace and in the middle point of the secondary cross. In one of those element is fixed the lightning rod (Figure 5.2).

Figure 5.1: A panoramic view of the spire and the cross that decorates it

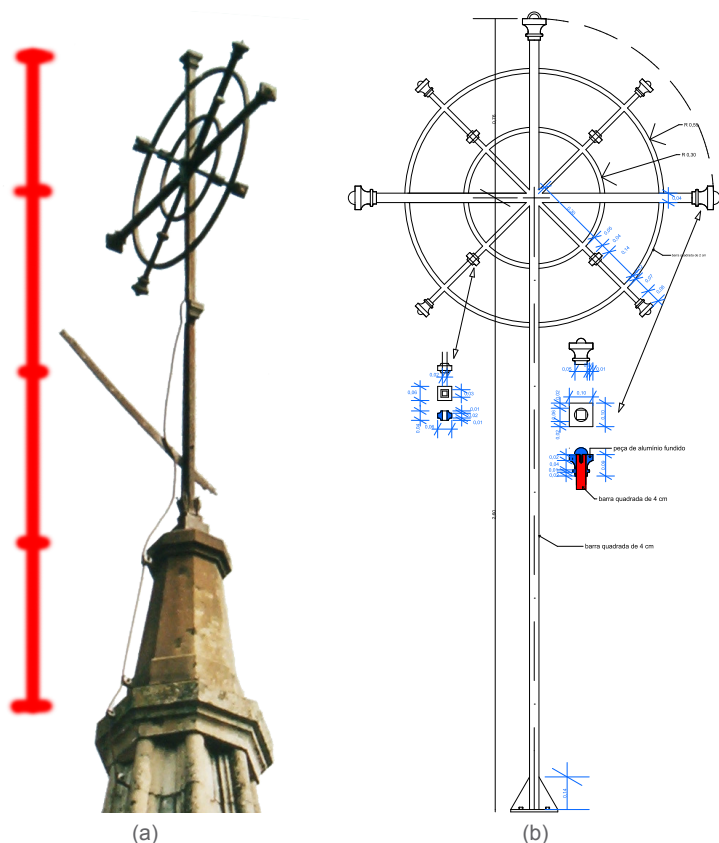
The dimensions of the cross were deducted thanks to previous drawings and photographic data archived in the Irmandade de S. Torcato and the museum (Figure 5.2 a). The problem on the element is induced by oxidation mechanisms that are severely damaging it, thus is required to replace the cross. However, several doubts and problems need to be solved before planning a strengthening design.

Figure 5.2: A closed view of the cross: (a) a real picture with the highlight of the proportions between the cross and the base stone (b) the first AutoCAD drawing developed before the visual inspection

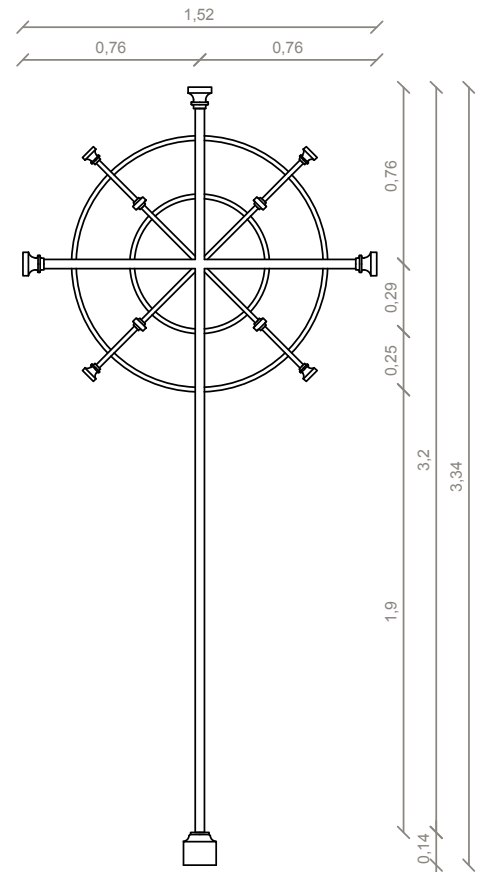
It was also possible to measure the cross system: basically, its thickness and the height of the base stone. All the other dimensions were calculated proportionally to those ones using pictures and historical data. An evident formal mistake was found in the technical drawings: the iron base

Figure 5.4: The update of the drawing after the visual inspection

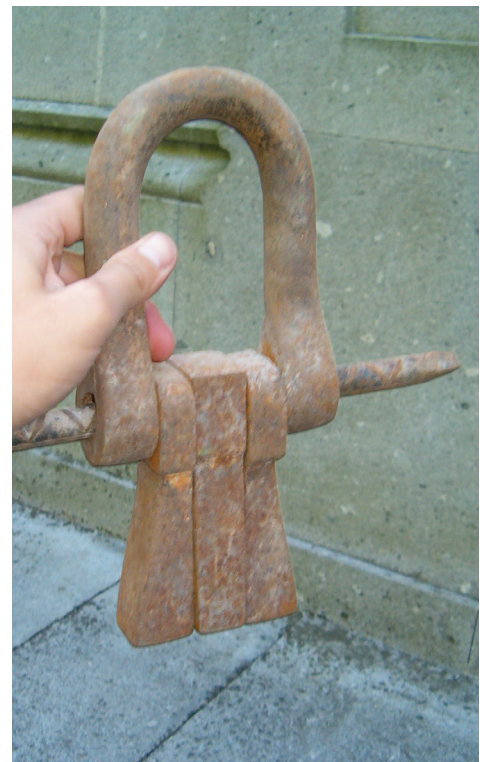
From the first visit, however, a big lack remained. It was not possible to understand the clamping system between the cross and the base stone by visual inspection. Several hypothesis were considered: the base could be hollow and base of the cross may be inserted on it for example. However, without any indirect test (by means of geo-radar for example) or a direct test (dismounting the cross), there are just speculations without documented bases. Few weeks after the visit, it was discovered a system used to lift the stones during the construction phases that could probably been used to clamp the cross. The system included the carving of a trapezoidal niche on the top of the base stone, 5 to 10 centimeters deep. Three iron parts would be hosted in the hole and connected by them with a transversal bar. The shape of those parts was such as once the bars were pulled up they were going to open and grab the stone from the inside (Figure 5.5).

Figure 5.5: Ancient clamp used to lift stones during construction phases

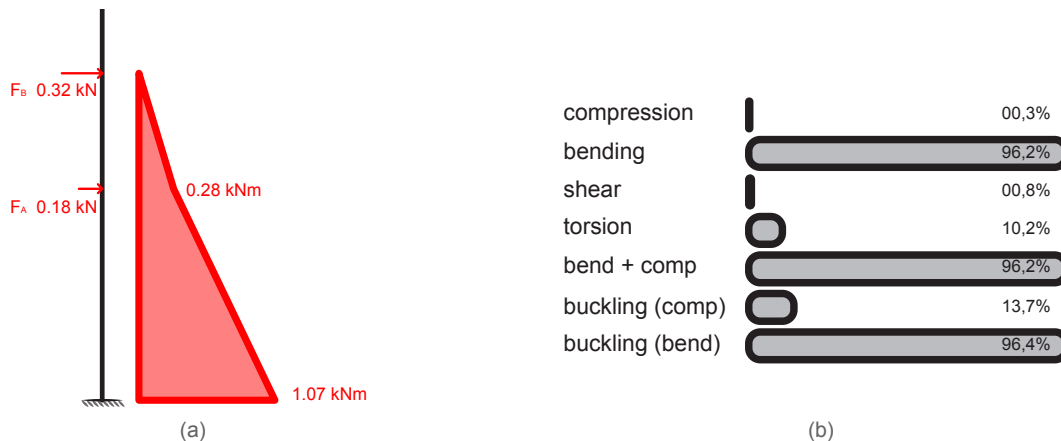
Imperfections and torsional effects were introduced as suggested by Eurocode, as well as second order effects. It was established that the cross satisfies all the requirements of the code. It results even over-designed for all the conditions with except of the pure bending one. The percentage of utilization of maximal resistance below each of the conditions is reported in Figure 5.8.

Figure 5.8: The results of the first analysis: (a) forces applied on the system and relative moment distribution (b) percentage of utilization of maximal resistance below each condition that affects the structure

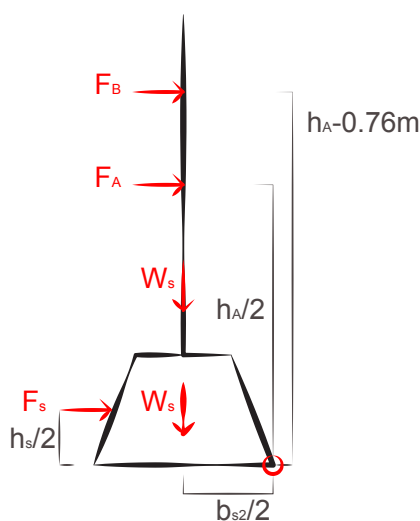
Figure 5.9: Simplified model used for develop the kinematic analysis

Those actions induce the overturning moment, counteracted by the resisting moment of the self-weight. The static equilibrium could not be reached with the made assumptions, so the analysis is failed. The acting design moment, in fact, is approximately four times higher than the other one. The problem cannot be due to an hypothetical bad approximation of the stone. Even if the shape or the weight of the stone should be tuned, it would be impossible to counteract the moment induced by the wind because of the big difference in force arms (Figure 5.9)

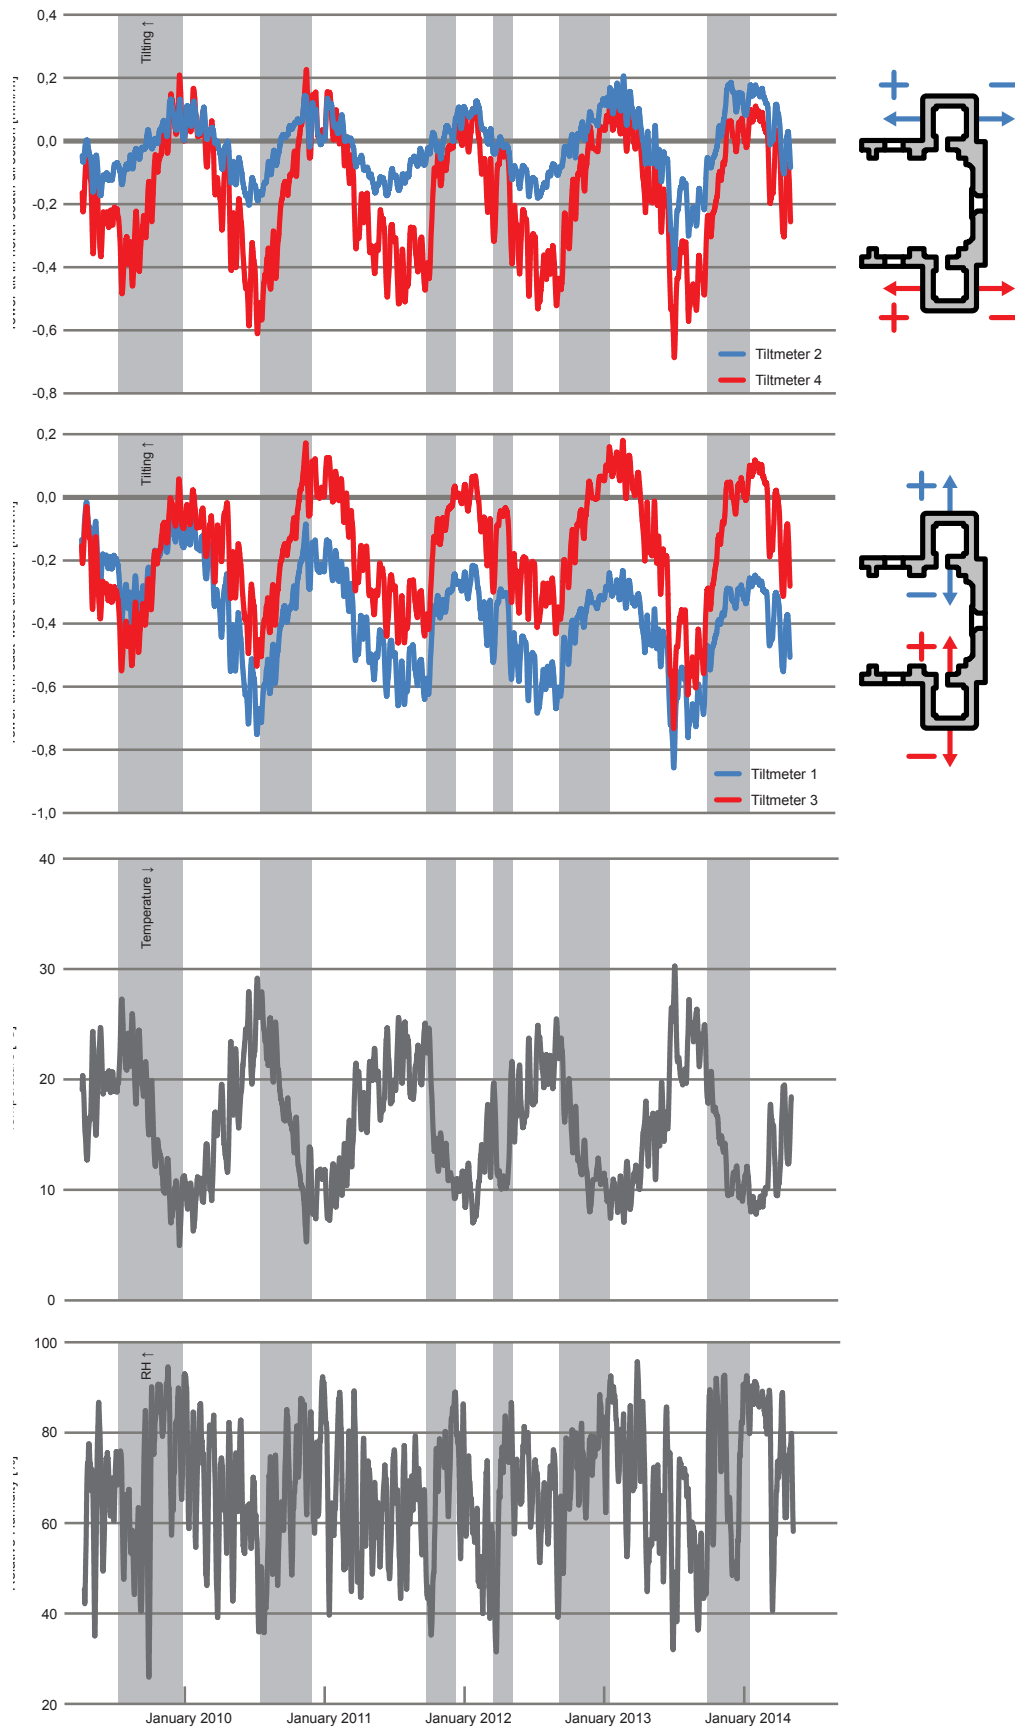
Figure 6.3: Analysis of the tilting monitoring data. The gray pattern shows the behavior of the towers with respect to the environmental conditions

Two tilt meters have been placed at the bells level of each tower, in order to collect the horizontal rotations of such structures. As shown in Figure 6.3, Tilt meter 1 and 2 have been placed on the right tower in order to analyze the rotations in east-west direction (Tilt meter 1) and north-south direction (Tilt meter 2). The others two sensors have been placed in the left tower for the same purpose: analyzing the movement in east-west direction (Tilt meter 3) and north-south direction (Tilt meter 4).

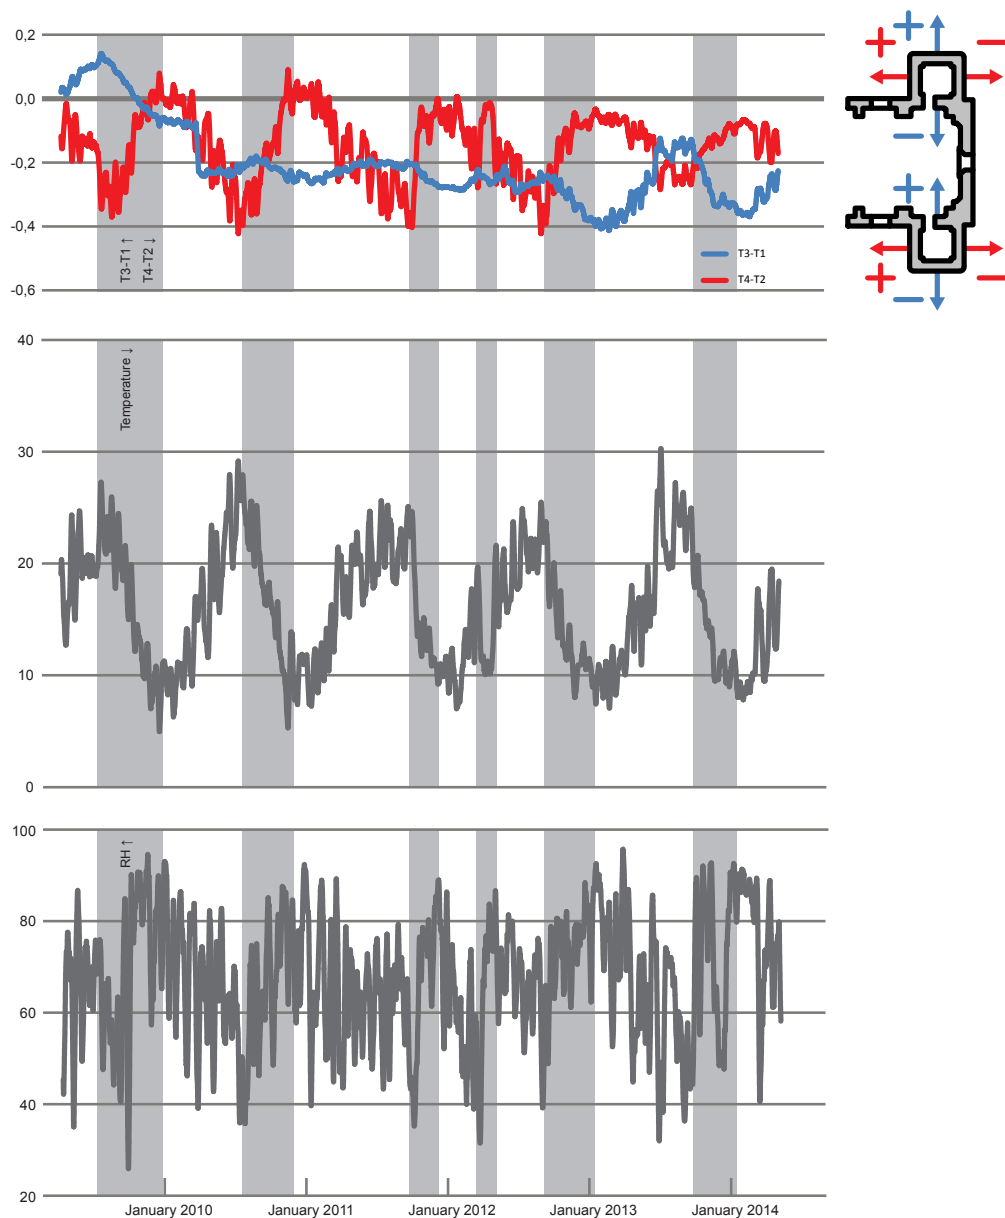
Figure 6.4: Differential behavior of the towers shown by the tilting monitoring data. The gray pattern shows the behavior of the towers with respect to the environmental conditions.

Even in this case it is possible to consider the strict relation with the structures trend and the exterior temperature. It can be inferred from the graph that the towers move basically in the same direction (Figure 6.4). The pattern of the displacements fits perfectly with seasonal fluctuation: a decrease of tempera-

It is really interesting to compare the relative tilting of the towers (Figure 6.4). The difference is much more marked for tilting out of the façade plane (Tilt meter 4 and 2) than for the in-plane movements. This difference could be induced by the structural scheme of the church and the relative rigidity of the walls: the movement out of plane could be less restricted than the in-plane movement. Moreover a step drop of the difference between Tilt meter 1 and 3 is visible around February 2010: the reason of this phenomenon are unknown, but could represent a change induced by an intervention on the church.

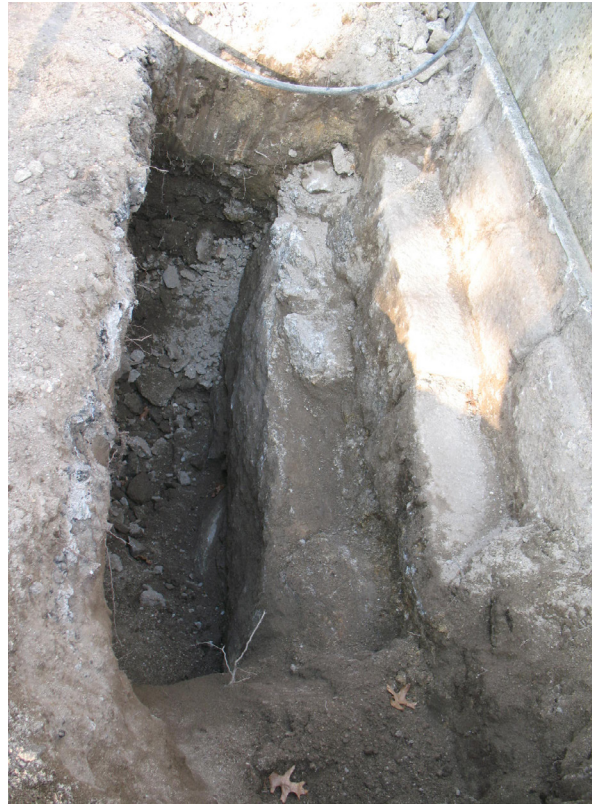
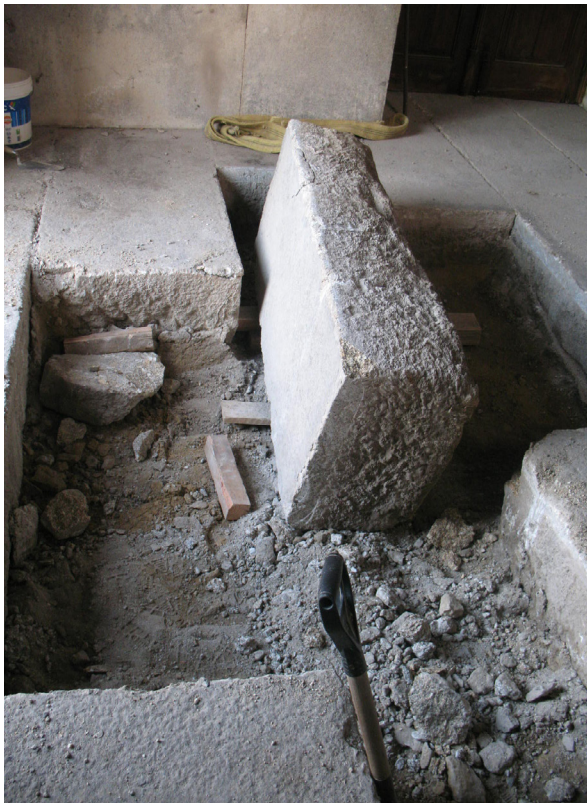
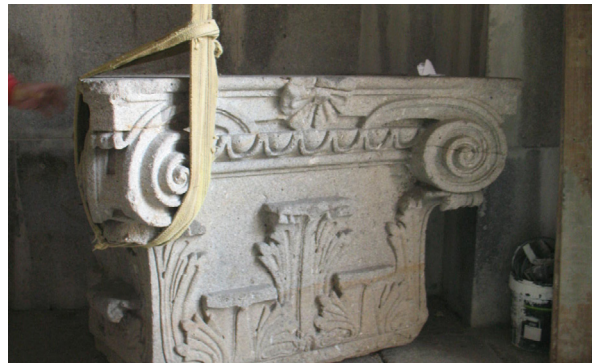
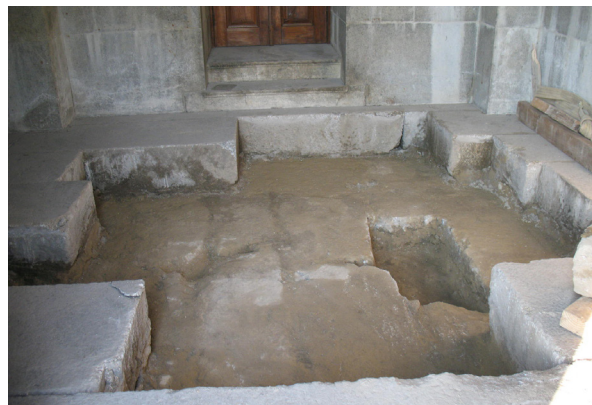
Figure 6.5: The removal of the granite stones: (a) marking of the exterior stones (b) the external foundations exposed (c) first phase of the intervention (d) removal of important details (e) the internal foundations exposed

A visual inspection was performed approximately one month before the effective beginning of the works. It was necessary to verify the real shape of the foundation both in the exterior side of the towers than in the interior one. For this purpose, the external pavement of both towers have been removed, taking care of mark and catalogue each stone, and the exposed soil has been dug until a suitable depth. The interior side of the towers has been worked in the same way, paying attention to important decorative elements stocked there (Figure 6.5).
